Proposed Hotel & Leisure (Commercial) Development

Site B, Porthcawl

Geo-Environmental & Geotechnical Assessment

Report Reference: ESP.7044d.3124_B.Rev1

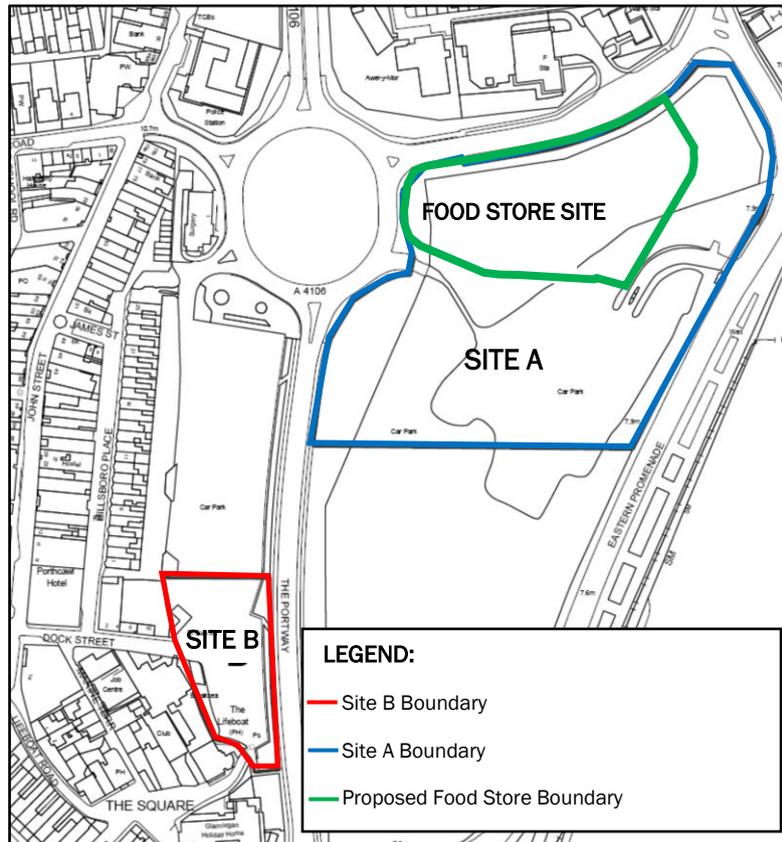
Insert 2 - Overview of Investigation Areas

This report relates to the investigation of the proposed hotel and commercial leisure facilities (such as a restaurant or café), hereafter known as Site B (indicated by the red boundary on Insert 2 below). The report for the proposed food store (within Site A) has been previously issued under separate cover (report ref: ESP.7044d.3112_C) and should be read if detailed context of this area is needed. The report for the investigation of Site A will be reported under separate cover (see Section 1.4).

The Earth Science Partnership Ltd (ESP), Consulting Engineers, Geologists and Environmental Scientists, were instructed by the Client to undertake an integrated geotechnical and geo-environmental investigation and initial assessment to preliminary identify and evaluate potential ground hazards which could impact on the proposed development in Site A and Site B (see Insert 2 below).

The site boundary in the environmental data report (Appendix C) and geological data report (Appendix D) is for the whole of Site A (see Insert 2). All distances stated in the reports are from the Site A boundary and not the Food Store site boundary and therefore where features are noted to be on-site this does not necessarily mean they are. Clarification has been provided throughout the report text to avoid confusion.

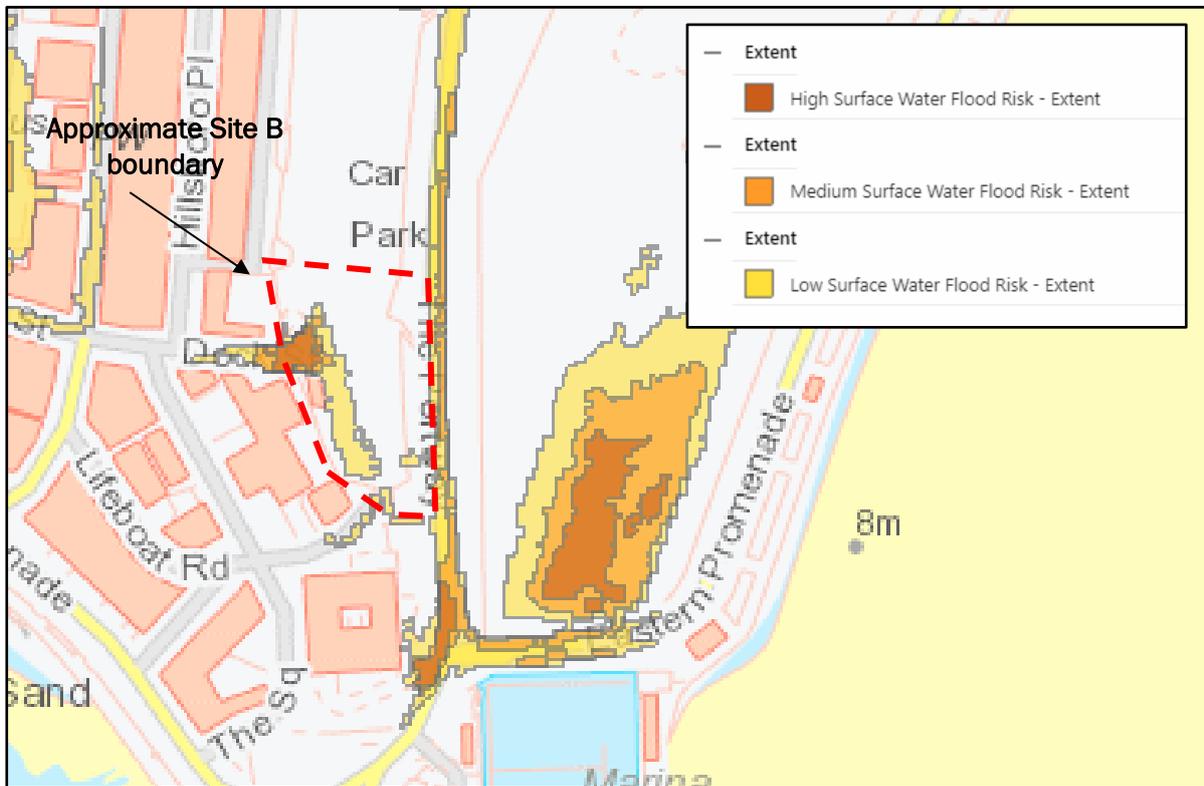
Insert 3 - Surface Water Flood Risk Map (NRW, 2019)

Reference to digital mapping on the Natural Resources Wales (NRW) website (NRW, 2019) indicates that an area in the west of the site is at low risk of surface water flooding, with an area of medium to high risk also indicated in the north west (see Insert 3 below).
